# HERMOSA BEACH BUILDING ASSESSMENT

ASCE 31-03 Phase 1 Structural  
Seismic Evaluation Report  
August 12, 2015

John A. Martin & Associates, Inc.

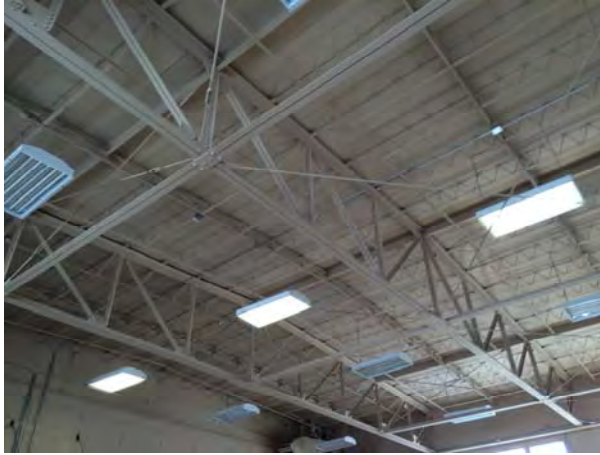
**Figure 1 – Steel Roof Trusses in Gymnasium**

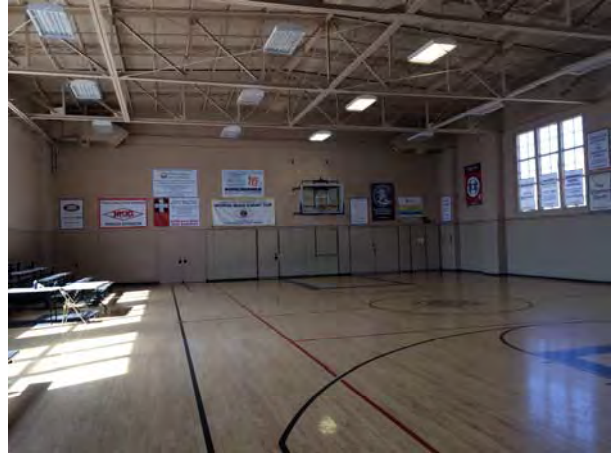
**Figure 2 –Gymnasium Floor**

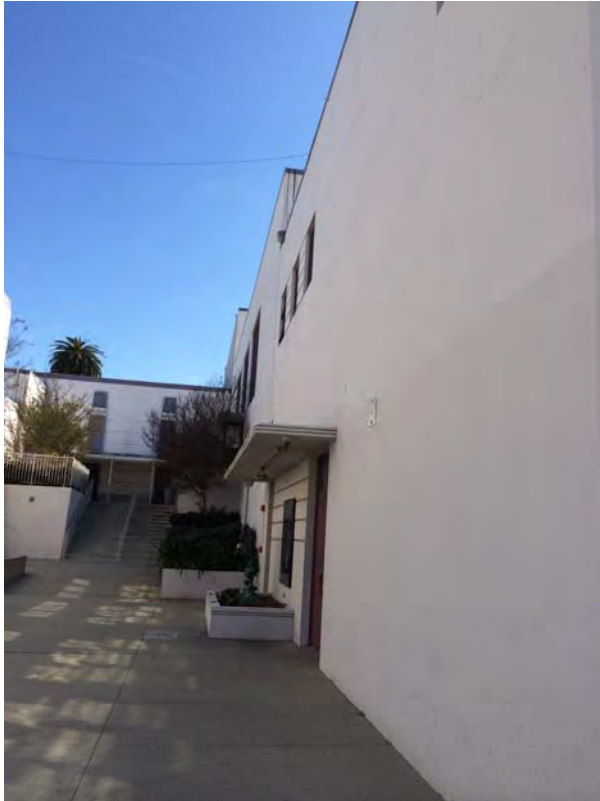
**Figure 3 – North Exterior Wall Looking East**

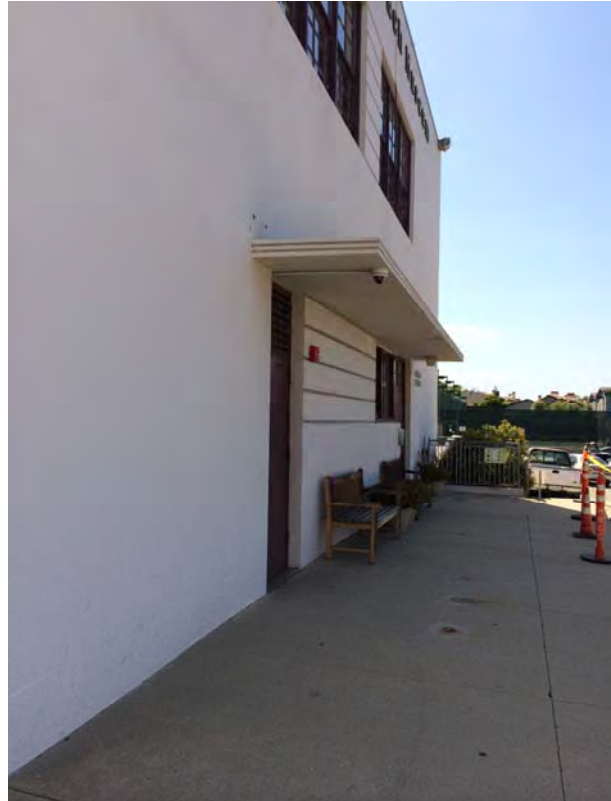
**Figure 4 – North Exterior Wall Looking West**
