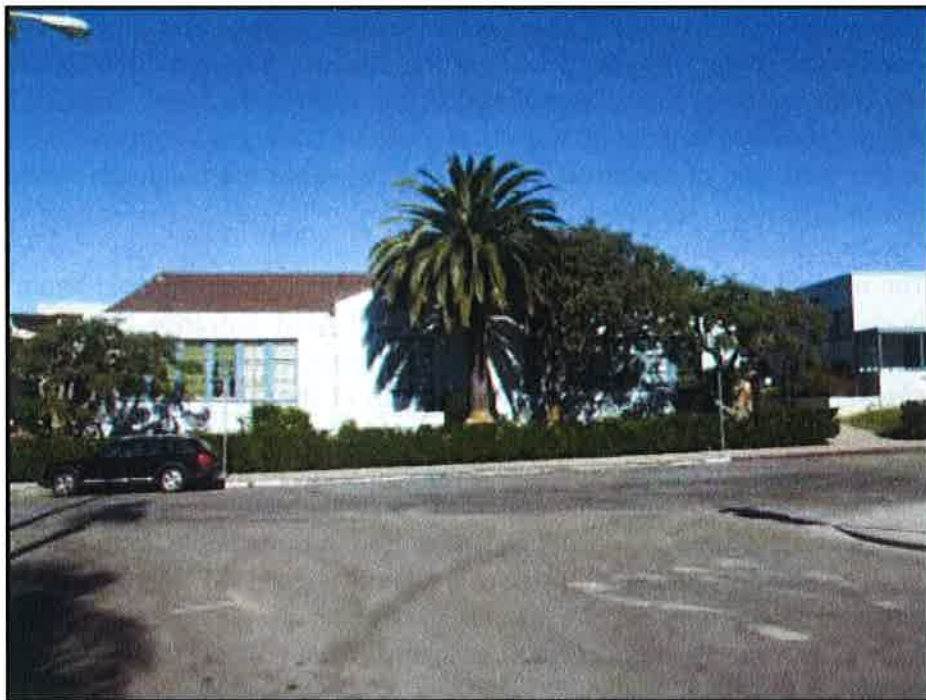
**Figure 13: Front (south) façade of the Main Building of North School presenting the exterior façade that is a result of the repairs and rehabilitation in 1934. View looking north.**
